Appendix F

Structures Visual Inspection Forms

FACILITIES CONDITION ASSESSMENT REPORT

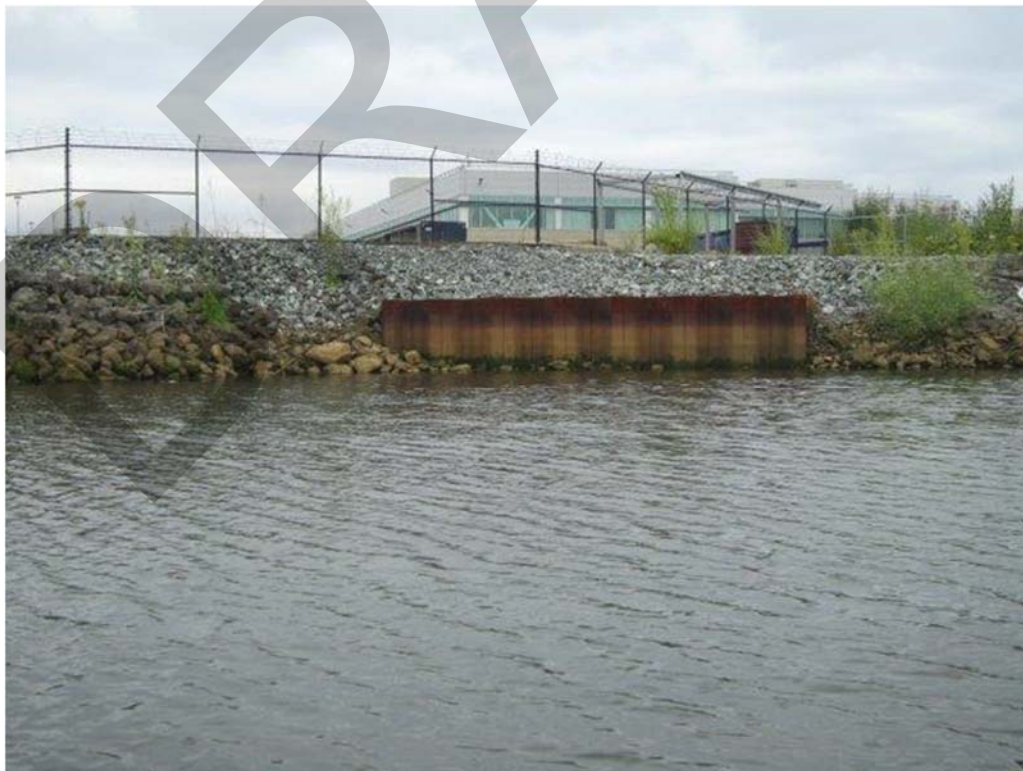
Photo ST03-02: Sheet Pile Bulkhead Section

- Close observation was not possible. However, except for the two relatively new segments of steel pile bulkheads (Photos 2, 6, and 7) which appear to be in good condition, the remainder of the bulkhead segments are in various states of indetermination.

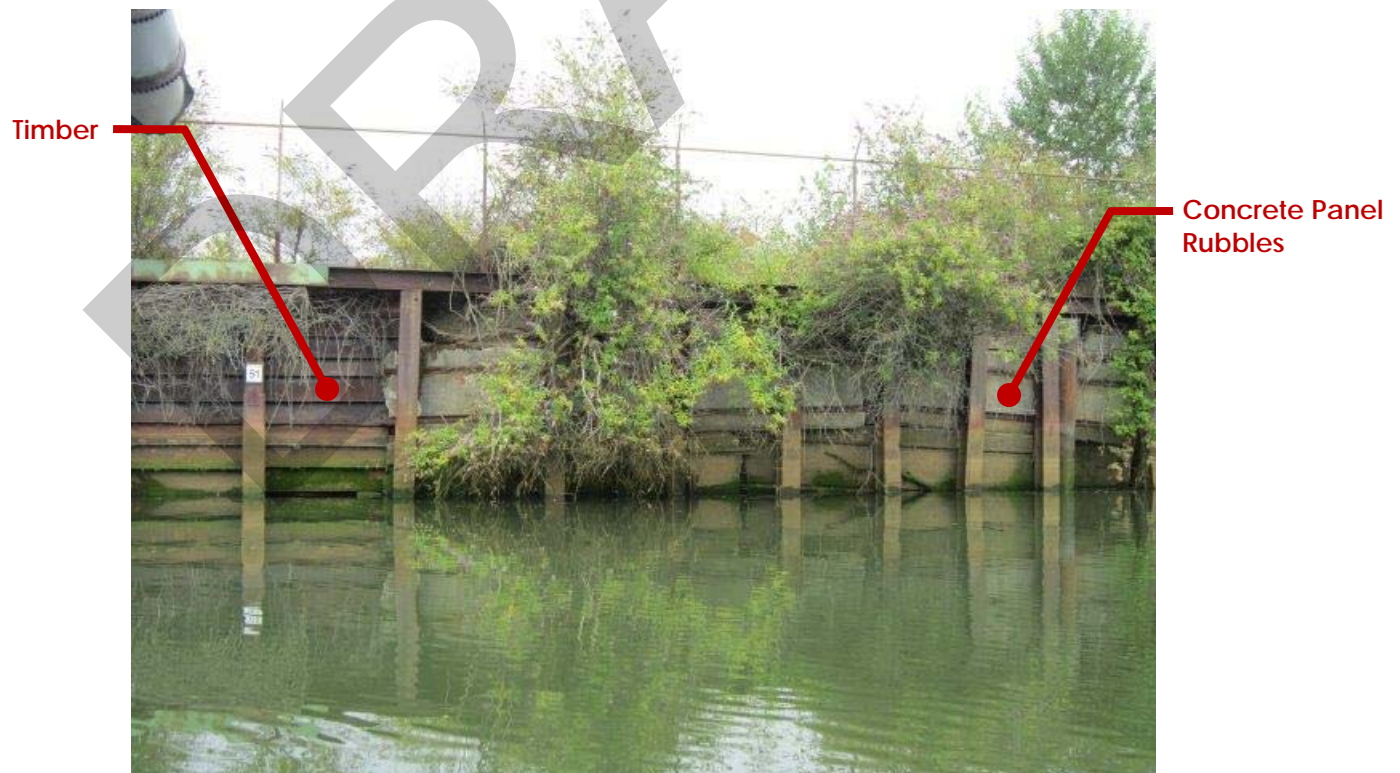
Photo ST03-10: H-Piles with Concrete Panel Rubbles

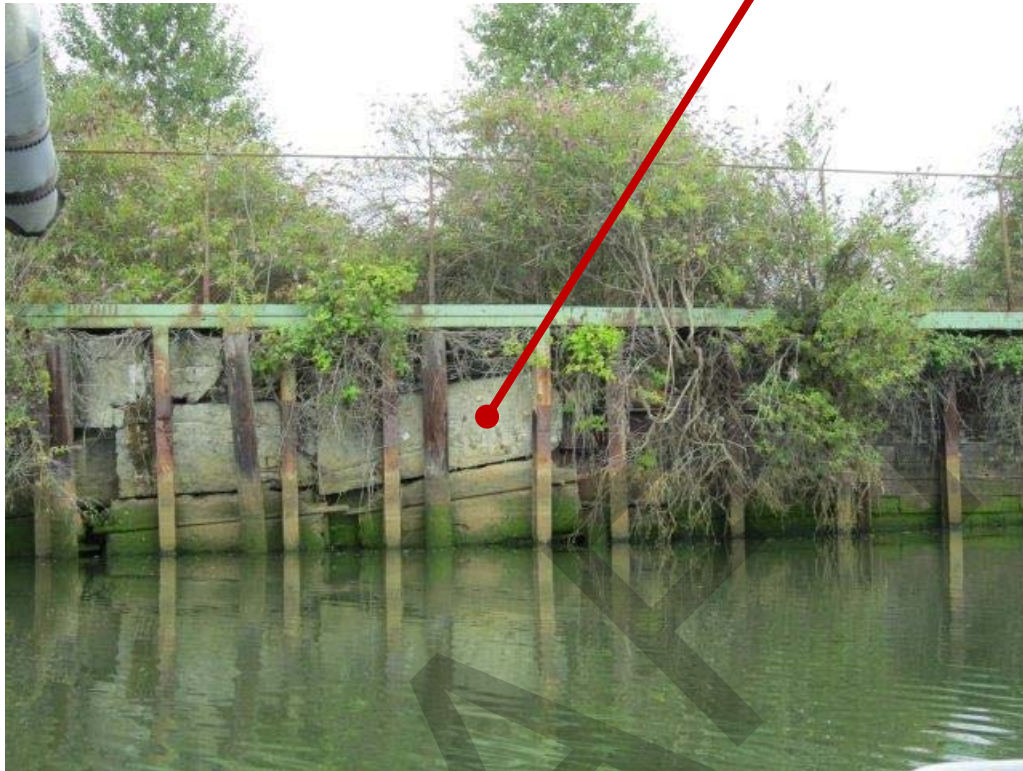
Photo ST03-11: H-Piles with Concrete Panel Rubbles

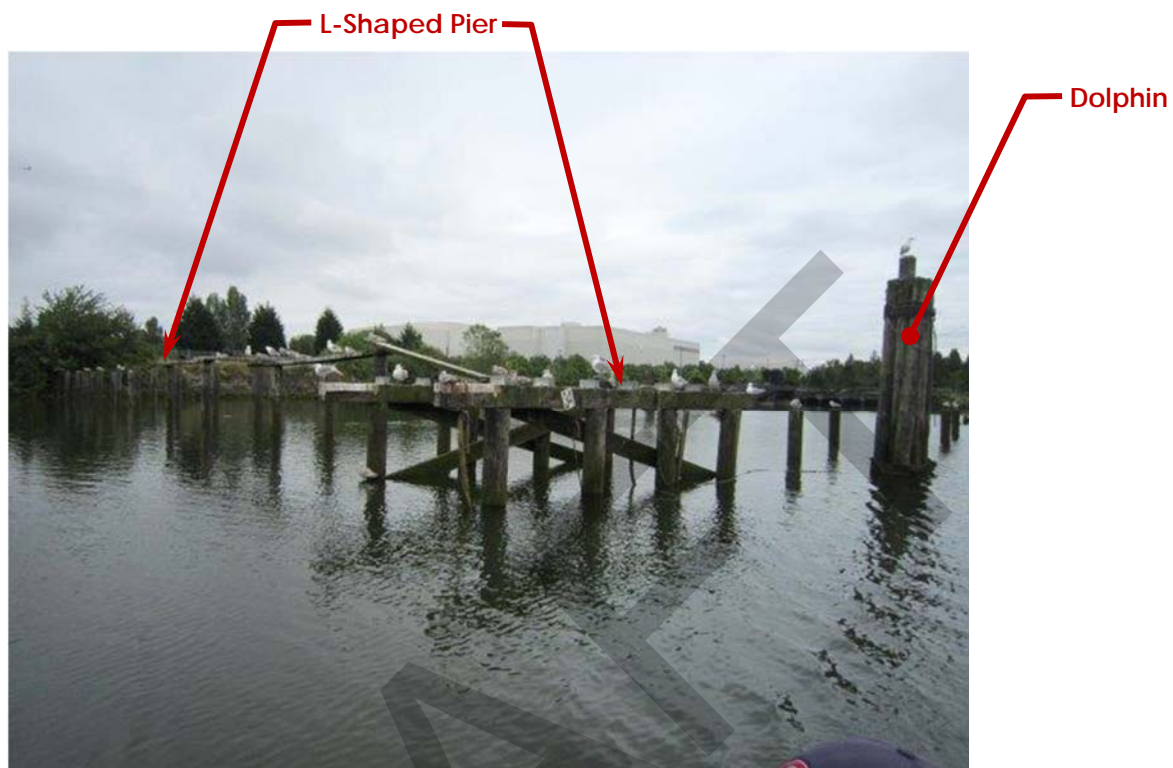
Photo ST41-01: L-Shaped Pier and Dolphins (Looking South)

- L-shaped pier of two (2) timber pile bents – One (1) leg extends west from the shore and the other offshore leg extends to the south.
- The pier is delapidated – Several piles are missing
- Along the south and west side of the pier are several 7-timber pile dolphins. The dolphins are still in use and are missing piles.
- The condition of the piles could not be assessed.

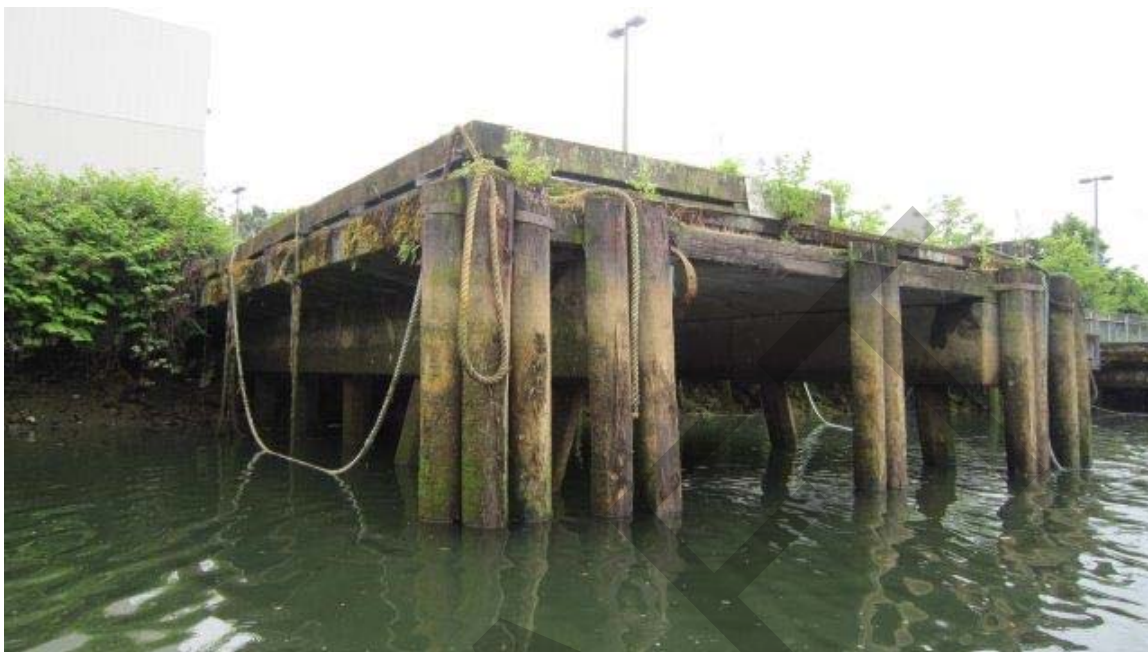
- The timber fender piles are generally intact except for the loose or missing straps. (Photos 1 and 2) The top of the piles appear to be rotted due to weather exposure and subsequent vegetation growth. The body of the piles within and above the splash zone appear to be sound and in good condition. Pressure treatment appears to be in good condition.

Photo ST44-01: Pier 1, East Most (Looking Southwest)

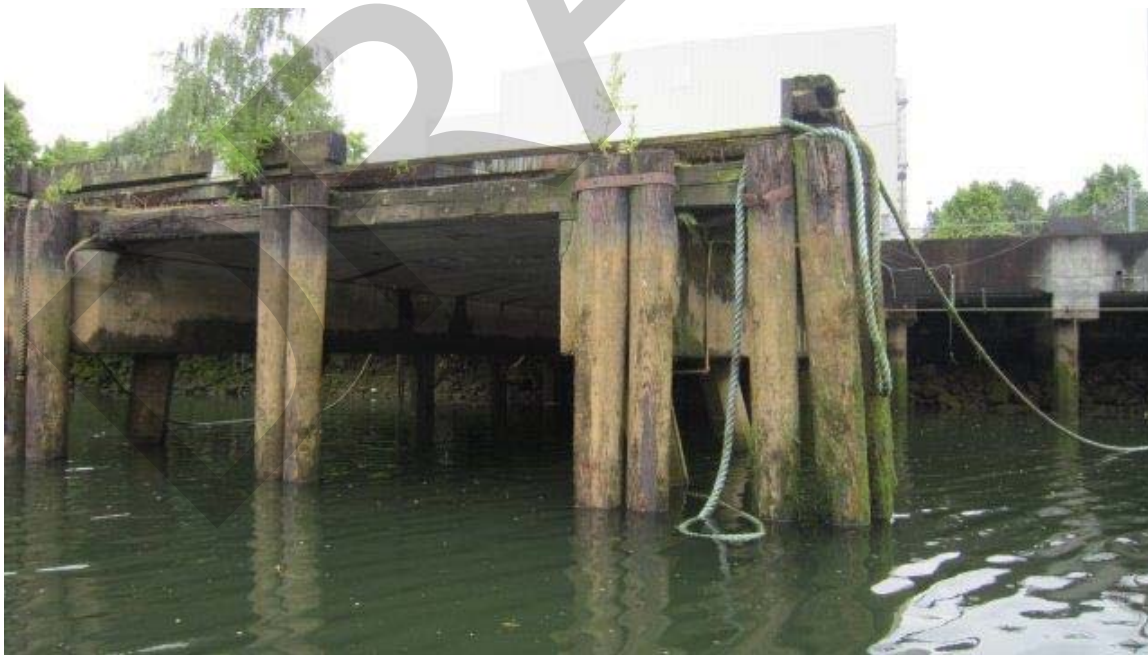
Photo ST44-02: Pier 1 (Looking South)

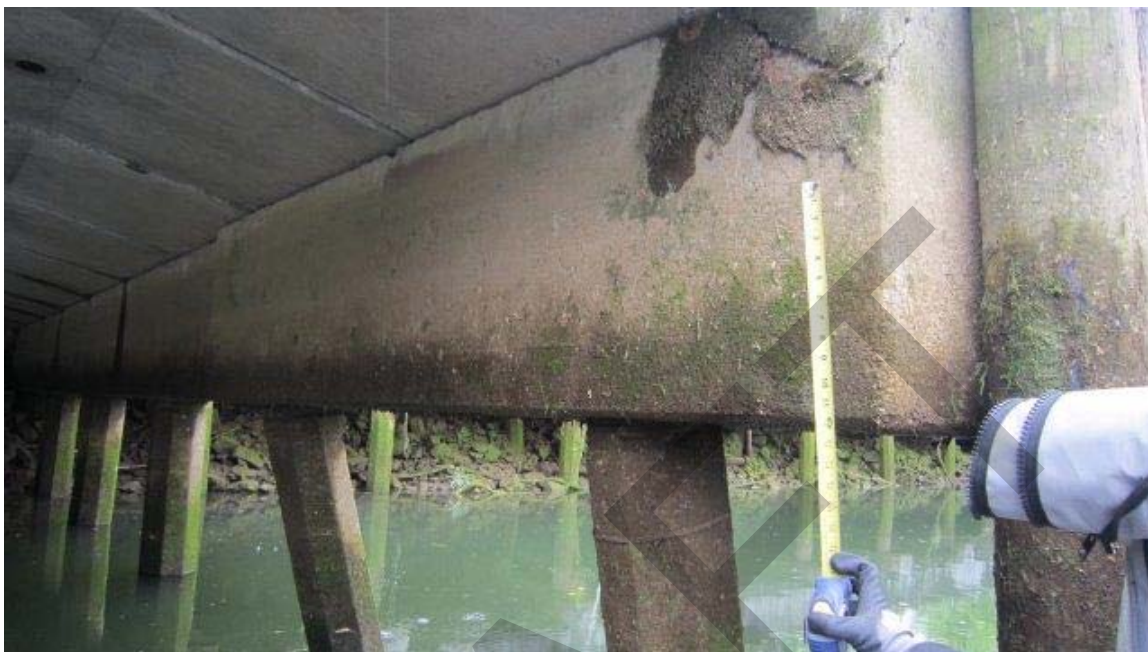
- The concrete piles are in good condition except for mortar surface erosion in the wet/dry zone of the piles (Photos 3 and 5).
- Along the length of the lower part of the pile cap is a crack. This is typical on all pile caps. (Photo 5)
- The pile caps are in good condition except for a loose concrete spall on the east face near the top of the cap and (b) mortar surface erosion in the splash zone (Photos 3 and 4).
- Pier decks are in good condition except for corrosion of exposed reinforcing bar in one of the panels (3rd panel from the north) and some rust stains between the 4th and 5th panel (Photos 6 and 7).

- a) Falling debris hazard due to loose concrete spall (Photos 3 and 4).
- b) Rot and decay at top of fender piles.
- c) Loose fender pile straps.
- d) Snag hazard due to loose mooring lines.

Photo ST44-03: Pier 1, East Side of West Pile Cap

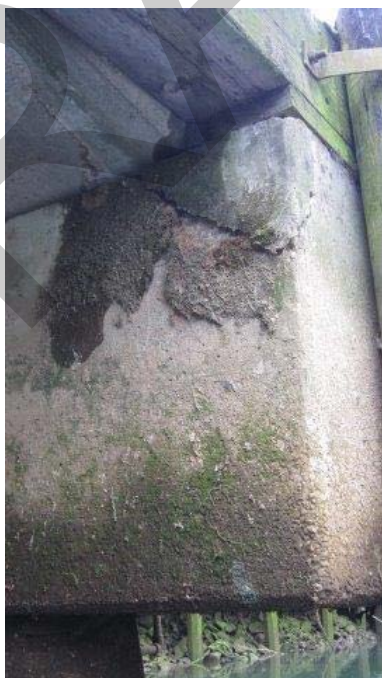
Photo ST44-04: Pier 1, East Side of West Pile Cap

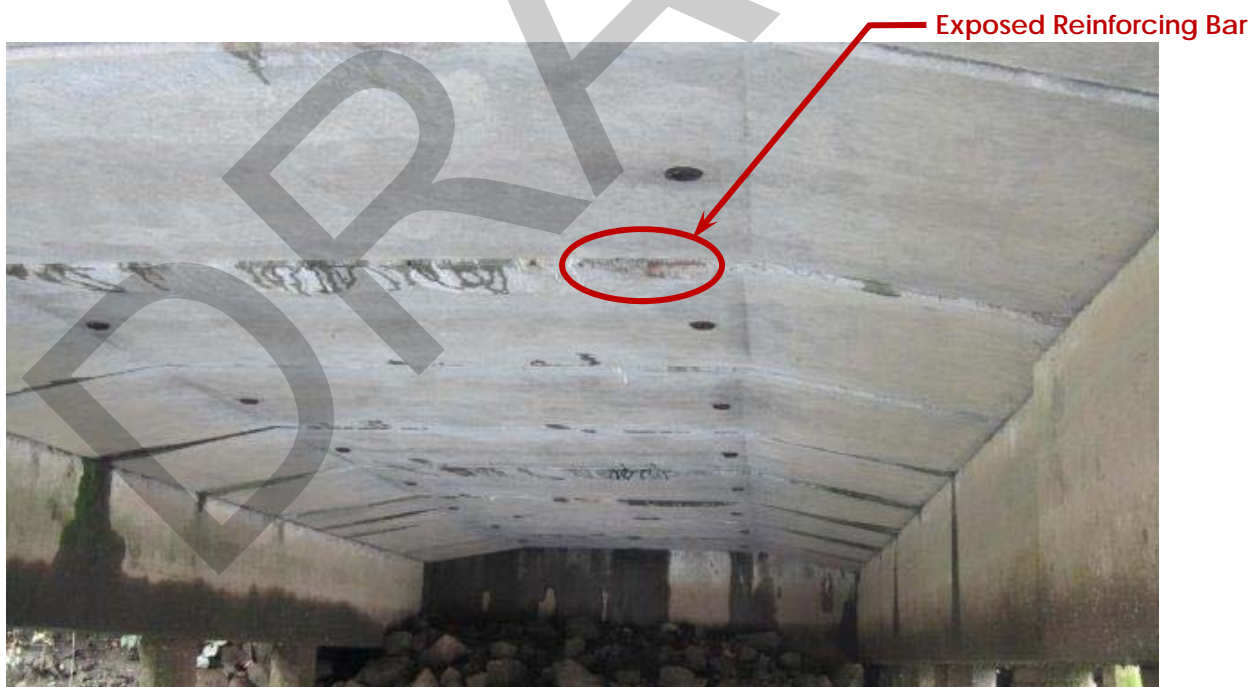
Photo ST44-06: Pier 1, Pier Deck Soffit

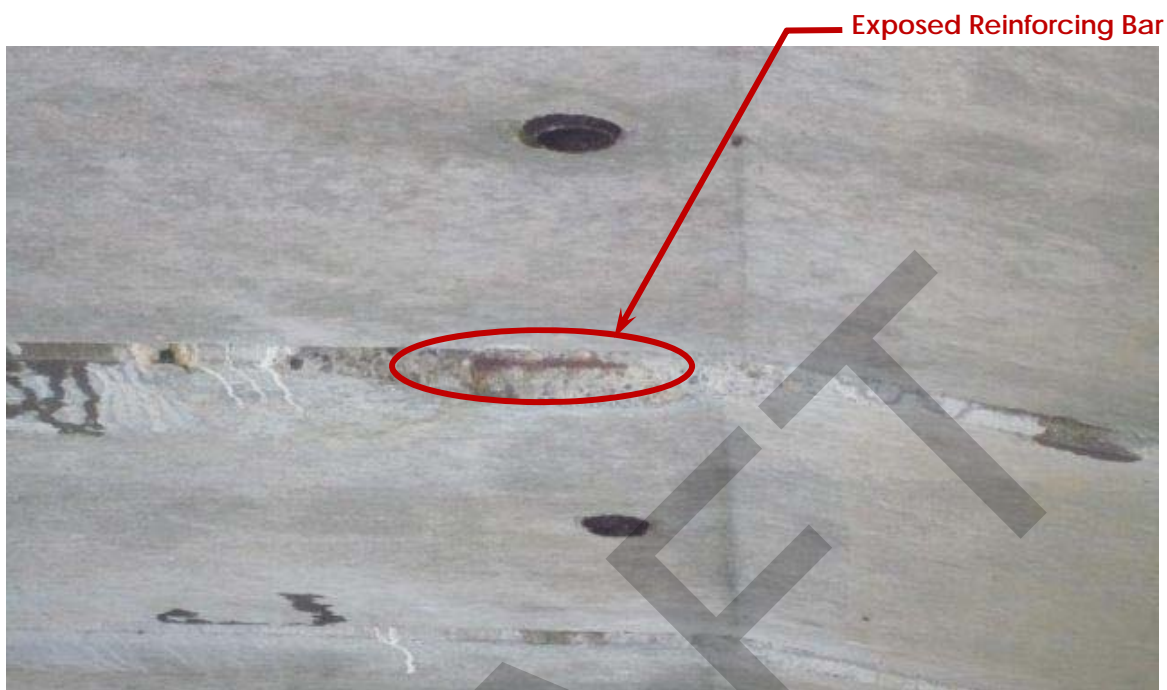
Photo ST44-07: Close Up of Exposed Reinforcing Bar

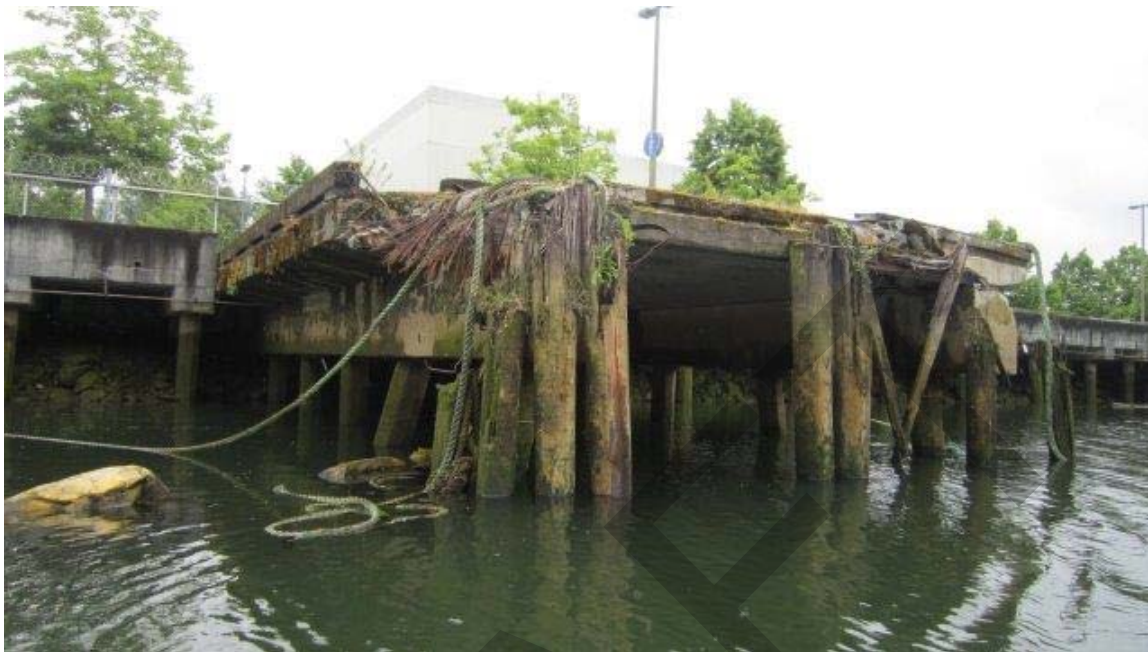
- Several timber fender piles are missing, broken, damaged, or missing straps. (Photos 9 and 10) The tops of the piles appear to be rotted due to weather exposure and subsequent vegetation growth. The body of the piles within and above the splash zone appear to be sound and in good condition. Pressure treatment appears to be in good condition.
- The concrete piles are in good condition except for mortar surface erosion in the wet/dry zone of the piles.
- The cap beams are in good condition except damage to the top of the west cap that exposes some reinforcing steel (Photos 10 and 11).
- The pier decks are in good condition except for portion of the west side of the first concrete deck panel is broken or partially demolished exposing some reinforcing bars (Photos 12 and 13).

- a) Falling debris hazard due to loose and damaged concrete of the pier deck and the top of deck (Photos 9, 12, and 13)
- b) Snag hazard due to loose mooring lines (Photos 9 and 10).

Photo ST44-09: Pier 2

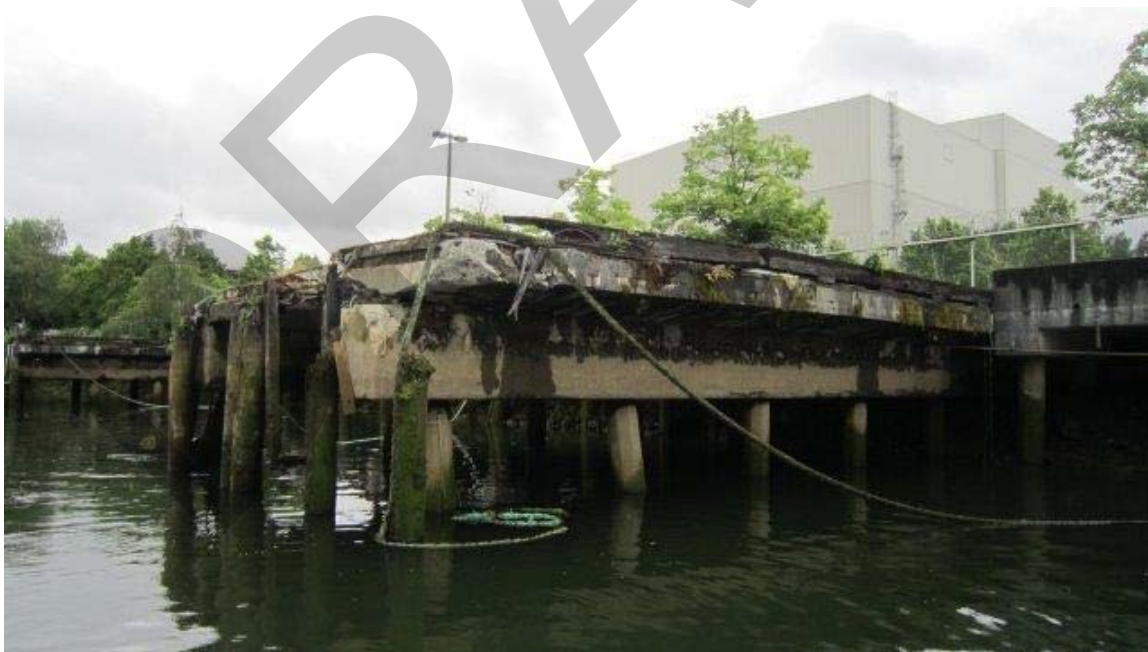
Photo ST44-10: Pier 2 (Looking Southeast)

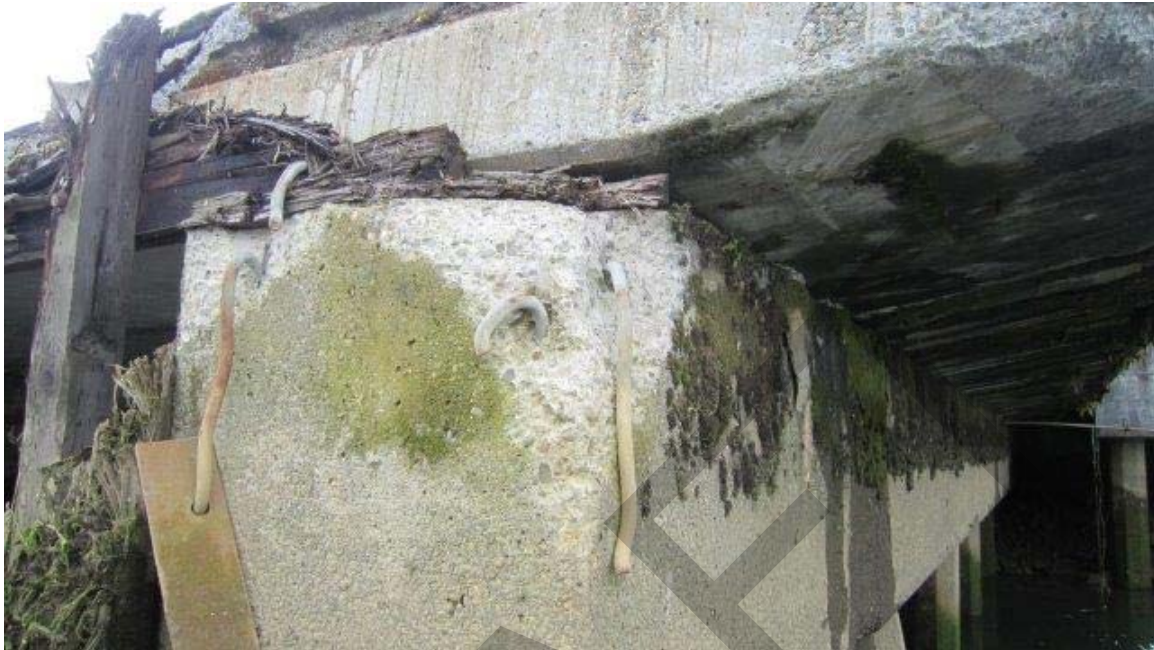
- c) Unprotected end of exposed reinforcing steel (Photo 11).
- d) Loose fender pile straps.
- e) It is not known if stub of missing piles exist above mud line.

Photo ST44-11: Pier 2, West Cap Beam

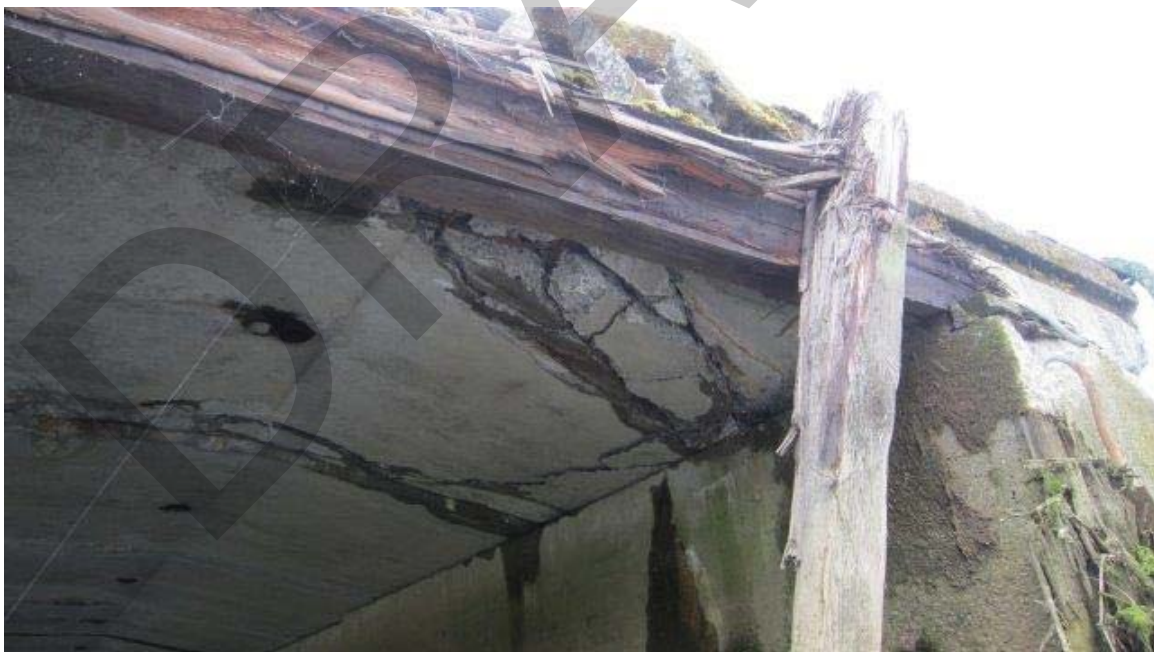
Photo ST44-12: Pier 2, Top West Corner of 1st Deck Panel

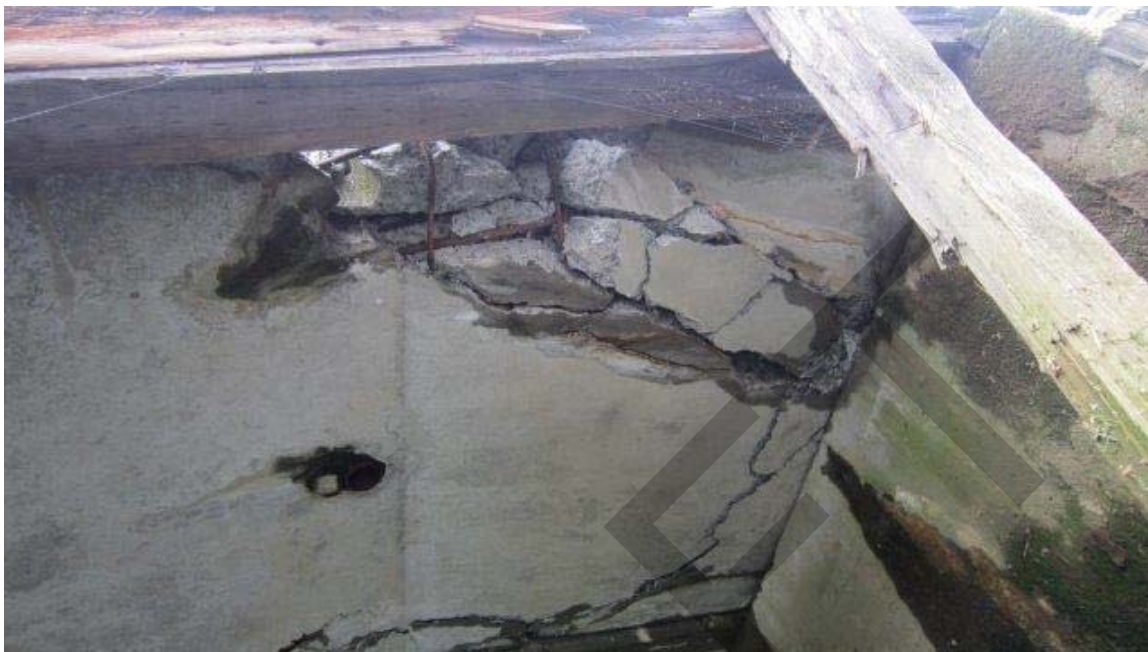
Photo ST44-13: Pier 2, Close Up of West Corner of 1st Deck Panel

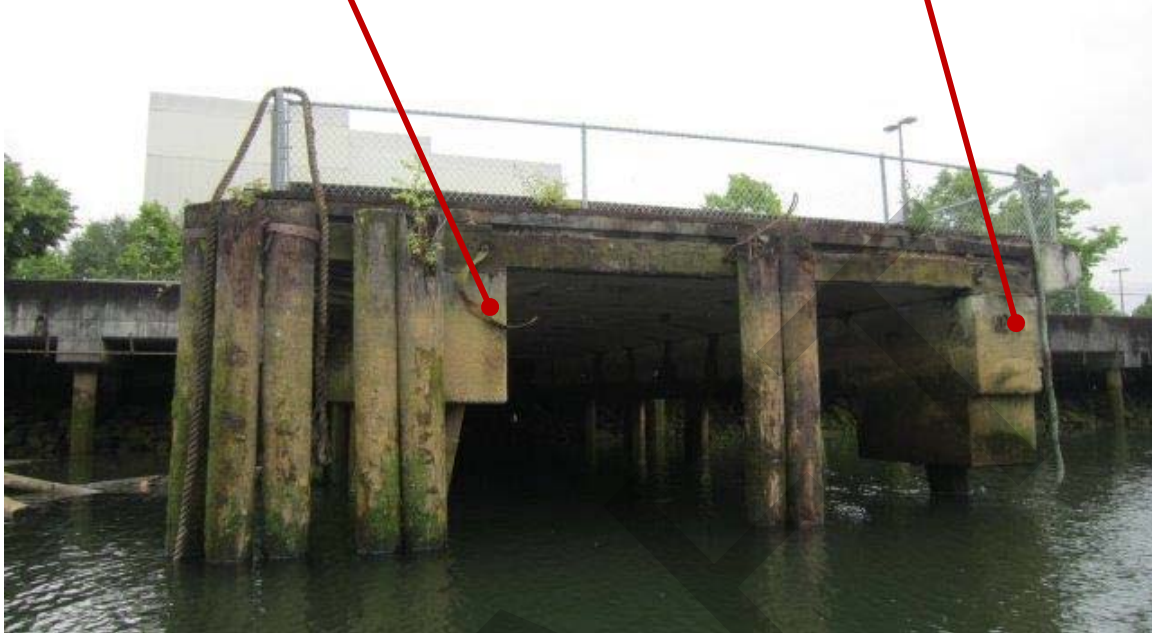
- Several timber fender piles missing with some loose or missing straps. (Photo 15) The tops of the piles appear to be rotted due to weather exposure and subsequent vegetation growth. The body of the piles within and above the splash zone appear to be sound and in good condition. Pressure treatment appears to be in good condition.
- The concrete piles are in good condition except for mortar surface erosion in the wet/dry zone of the piles.
- The pile caps are in good condition except for the north end of the east cap beam is wider and the west pile cap is deeper than the typical cap configuration (Photos 15 and 16).
- Concrete pier decks are in good condition (Photo 17).

Wider Pile Cap

Deeper Pile Cap

Photo ST44-15: Pier 3

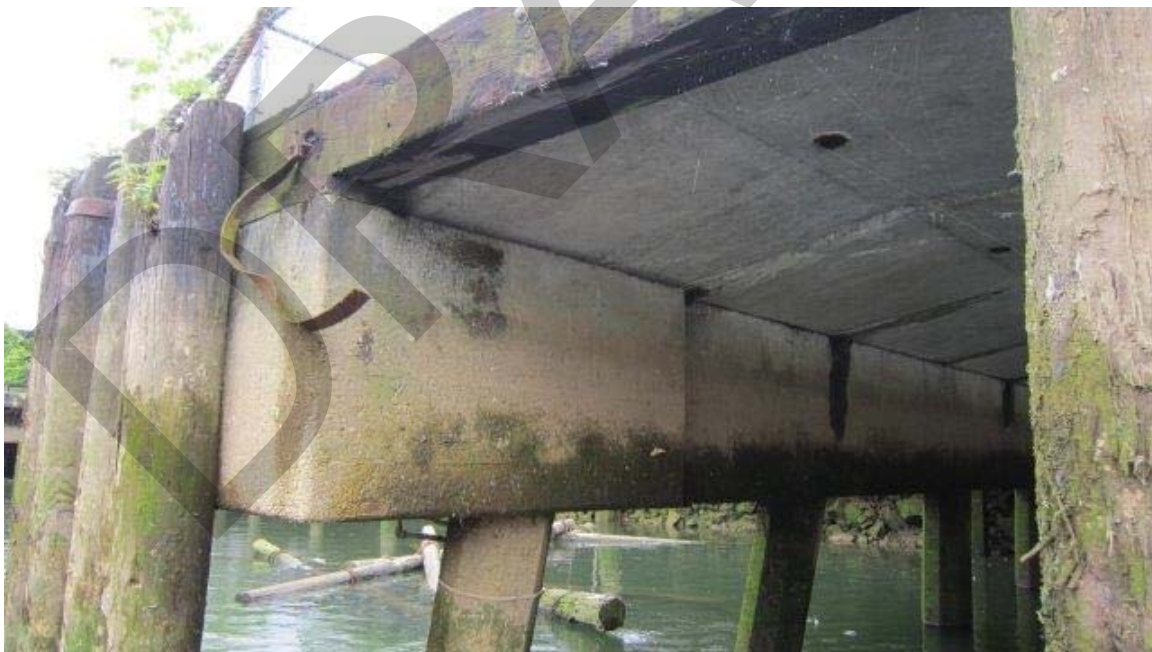
Photo ST44-16: Pier 3, East Pile Cap

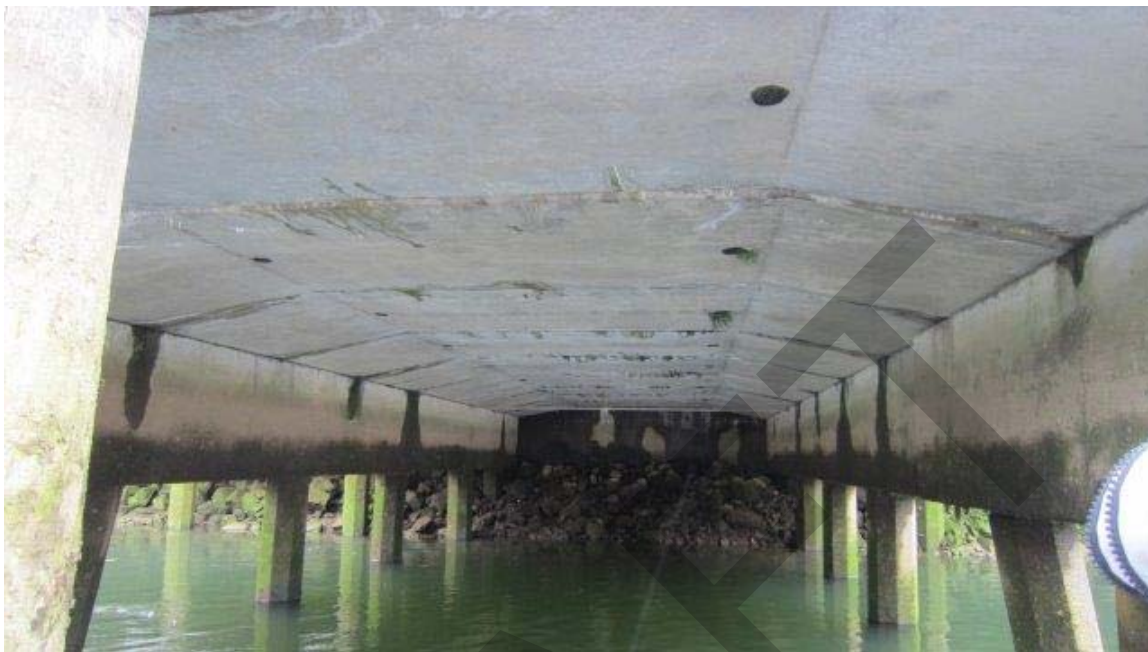
Photo ST44-17: Pier 3, Pier Deck Soffit

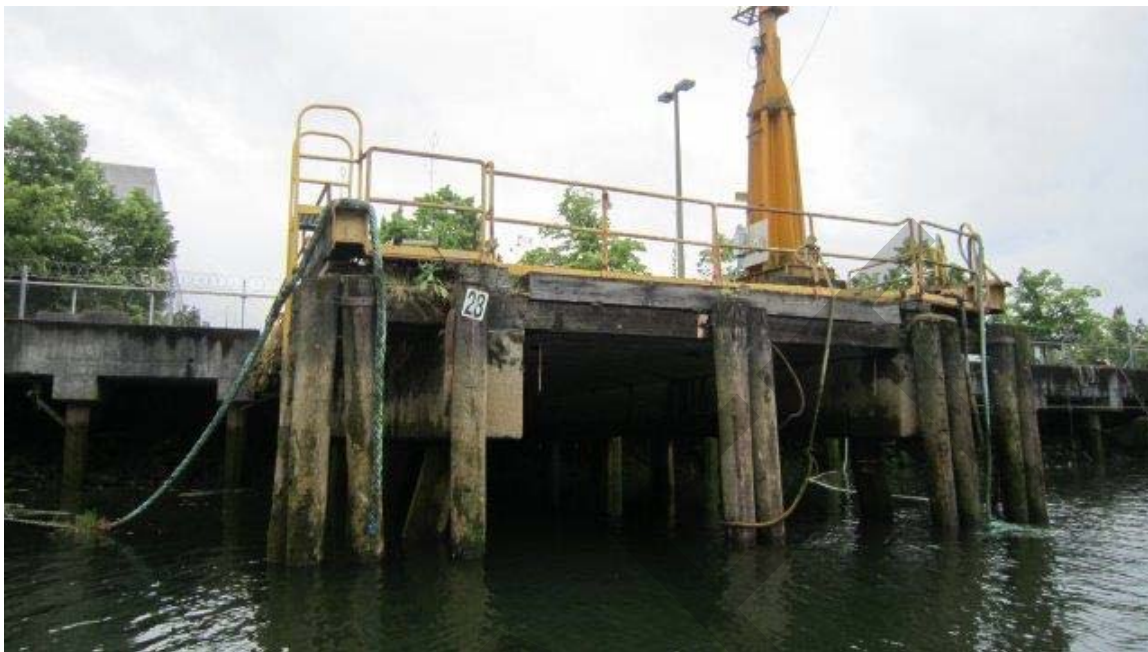
- A few timber fender piles missing with some loose or missing straps. (Photo 19) The tops of the piles appear to be rotted due to weather exposure and subsequent vegetation growth. The body of the piles within and above the splash zone appear to be sound and in good condition. Pressure treatment appears to be in good condition.
- The concrete piles are in good condition except for mortar surface erosion in the wet/dry zone of the piles.
- The pile caps are in good condition except for the pile caps are approximately 32" wide x 42" deep and the depth of the west cap over the first pile is deeper than typical.
- Concrete pier decks are in good condition (Photo 20).

Photo ST44-19: Pier 4

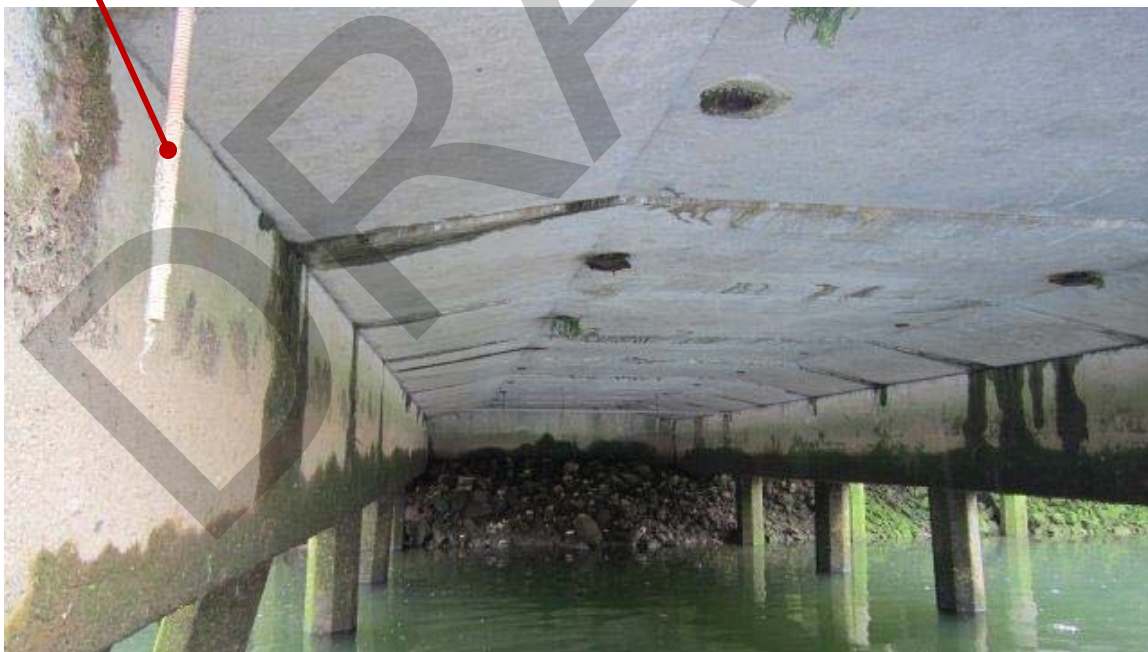
- a) Rot and decay at top of fender pile.
- b) Loose fender pile straps.
- c) It is not known if stub of missing piles exist above mud line.
- d) Snag hazard due to loose mooring lines.
- e) Hanging Steel Rod in board of west pile cap (Photo 20).

Hanging Steel Rod

Photo ST44-20: Pier 4, Pier Deck Soffit

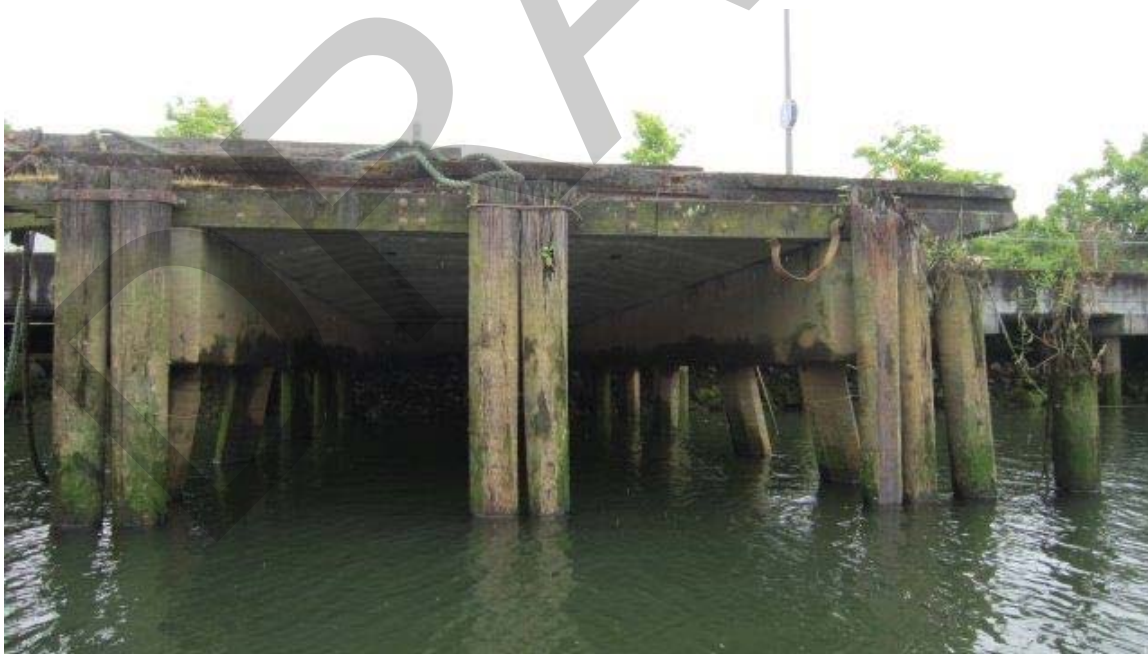
- Several timber fender piles missing or broken with some loose or missing straps. (Photo 22) The tops of several piles appear to be rotted due to weather exposure and subsequent vegetation growth. The

body of the piles within and above the splash zone appear to be sound and in good condition. Pressure treatment appears to be in good condition.

Photo ST44-22: Pier 5

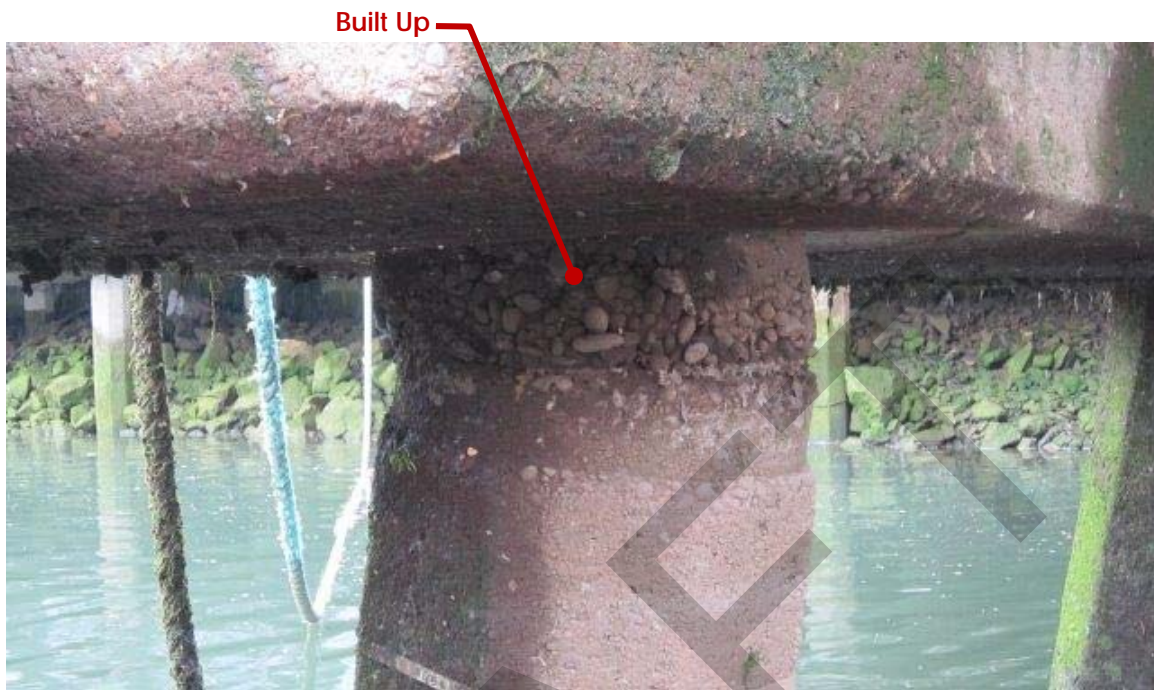
- The concrete piles are in good condition except for mortar surface erosion in the wet/dry zone of the piles. The top 6-in of the first pile to the east appears to be field built up and contains rock pockets (Photo 23).
- The pile caps are in good condition except for the pile caps are 32" wide x 42" deep, wider than typical dimensions.
- Concrete pier decks are in good condition (Photo 24)

Photo ST44-23: Pier 5, Bent 1 East Cap Beam

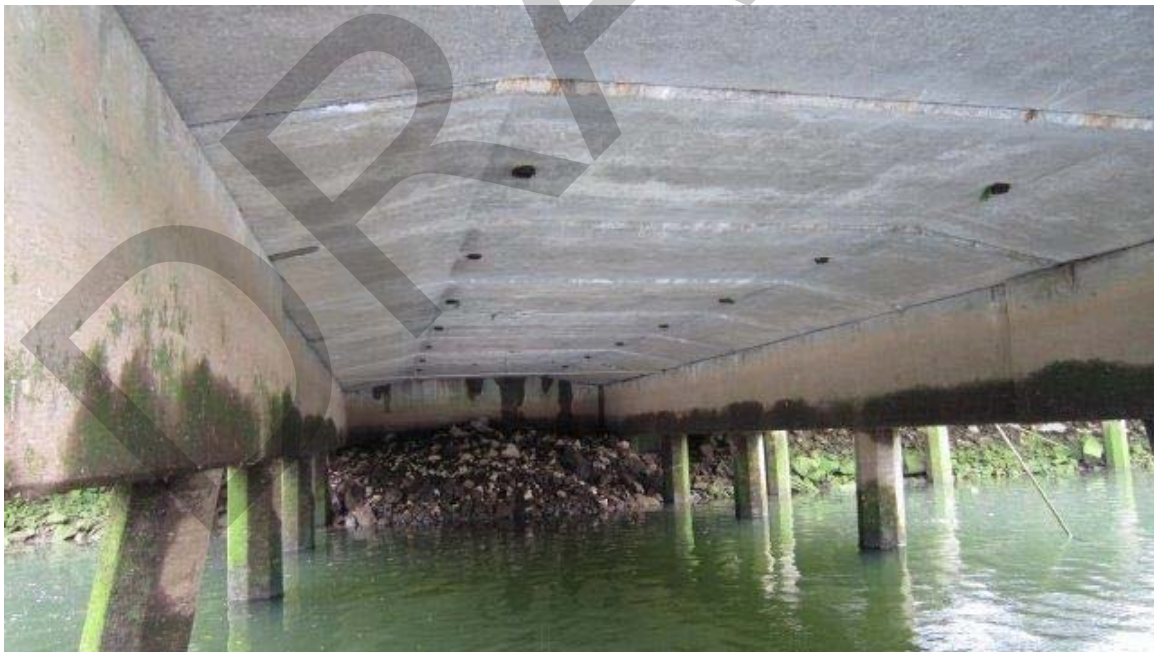
Photo ST44-24: Pier 5, Pier Deck Soffit

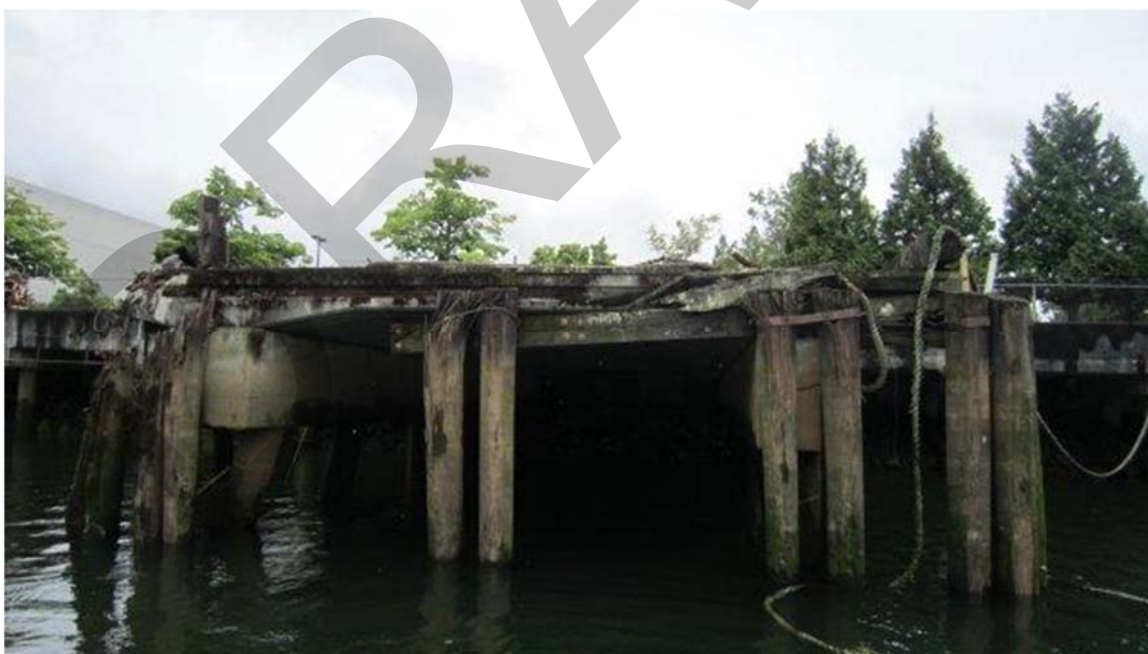
- Most timber fender piles are missing, broken, or damaged. Some with loose, damaged, or missing straps (Photos 26 and 27). The tops of the piles appear to be rotted due to weather exposure and subsequent vegetation growth. The body of the piles within and above the splash zone appear to be sound and in good condition. Pressure treatment appears to be in good condition.
- The concrete piles are in good condition except for mortar surface erosion in the wet/dry zone of the piles (Photos 28 and 29).
- The pile caps are in good condition except for the pile caps are wider than typical dimensions (Photos 28 and 29).
- Concrete pier decks are in good condition except for damage at top west corner with broken concrete and exposed reinforcing steel (Photos 27 to 29).

Photo ST44-26: Pier 6

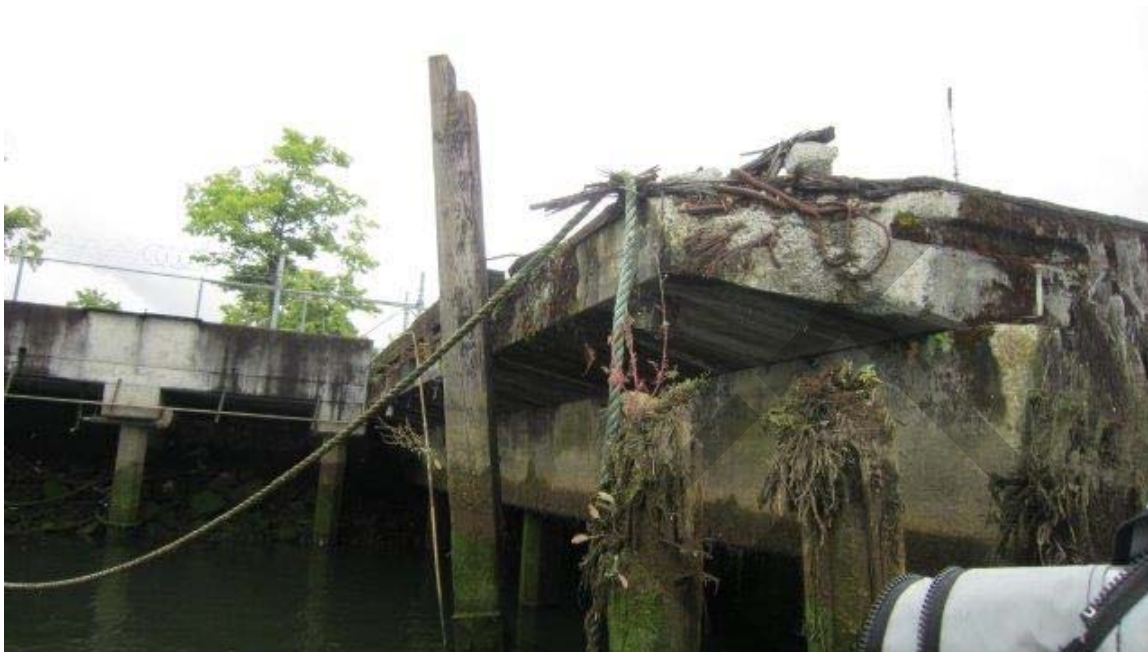
Photo ST44-27: Pier 6, East Side

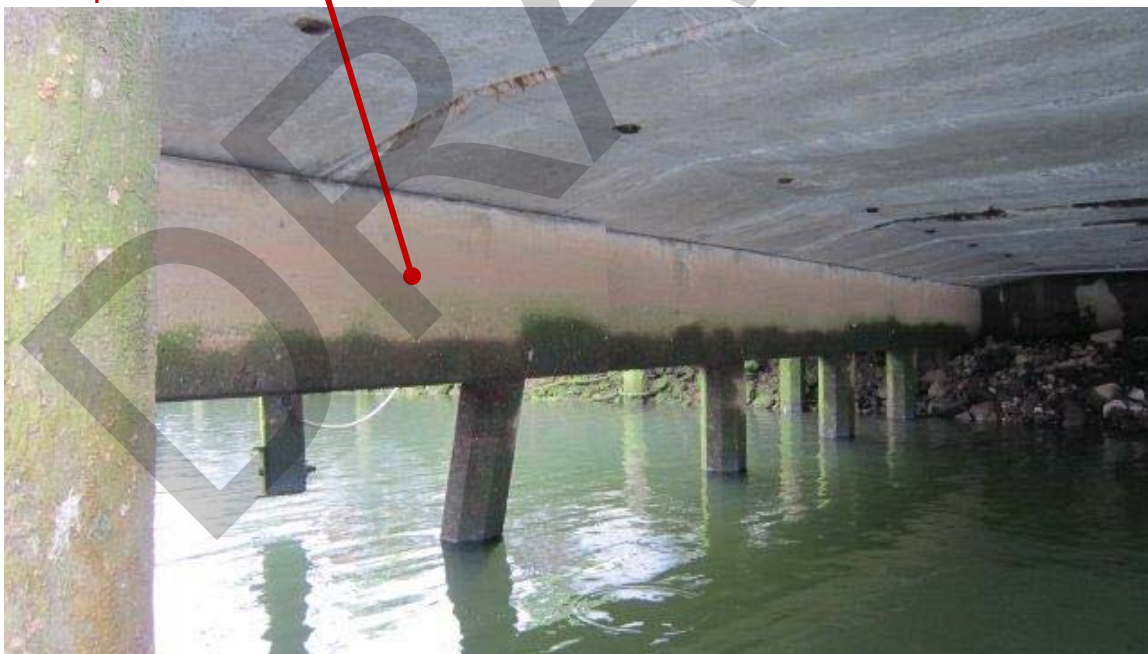
Wider Cap – Over 2 Piles

Photo ST44-28: Pier 6, East Pile Cap

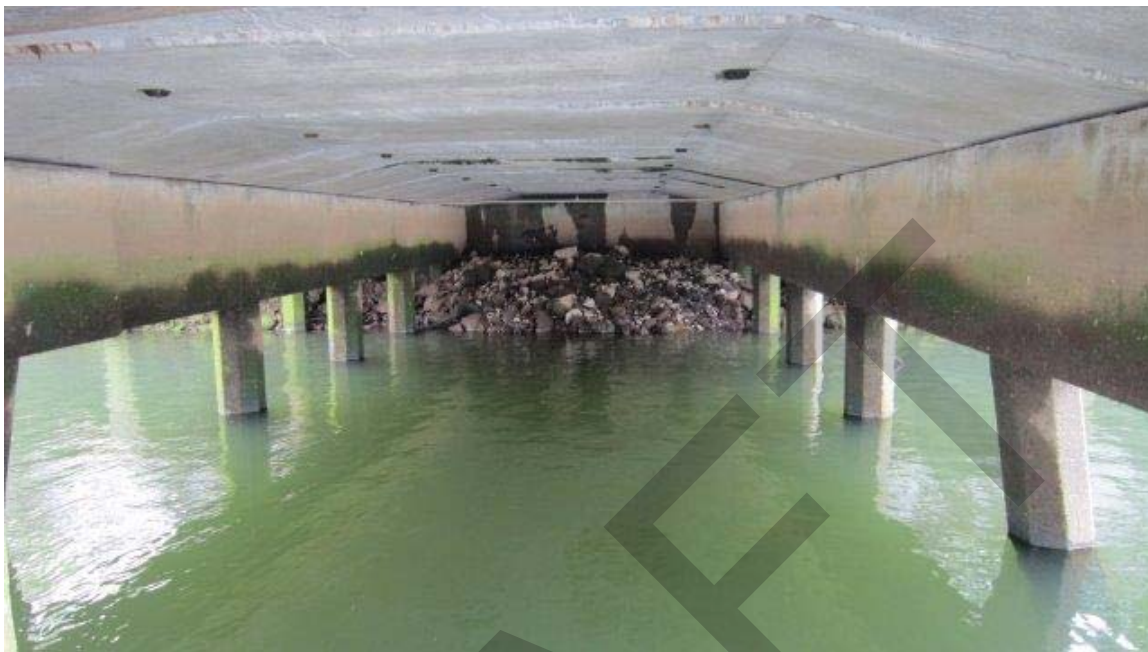
Photo ST44-29: Pier 6, Pier Deck Soffit
